FINAL
SECOND INSTALLATION-WIDE FIVE-YEAR REVIEW REPORT
JOINT BASE LEWIS-MCCHORD
PIERCE COUNTY, WASHINGTON

SEPTEMBER 2017

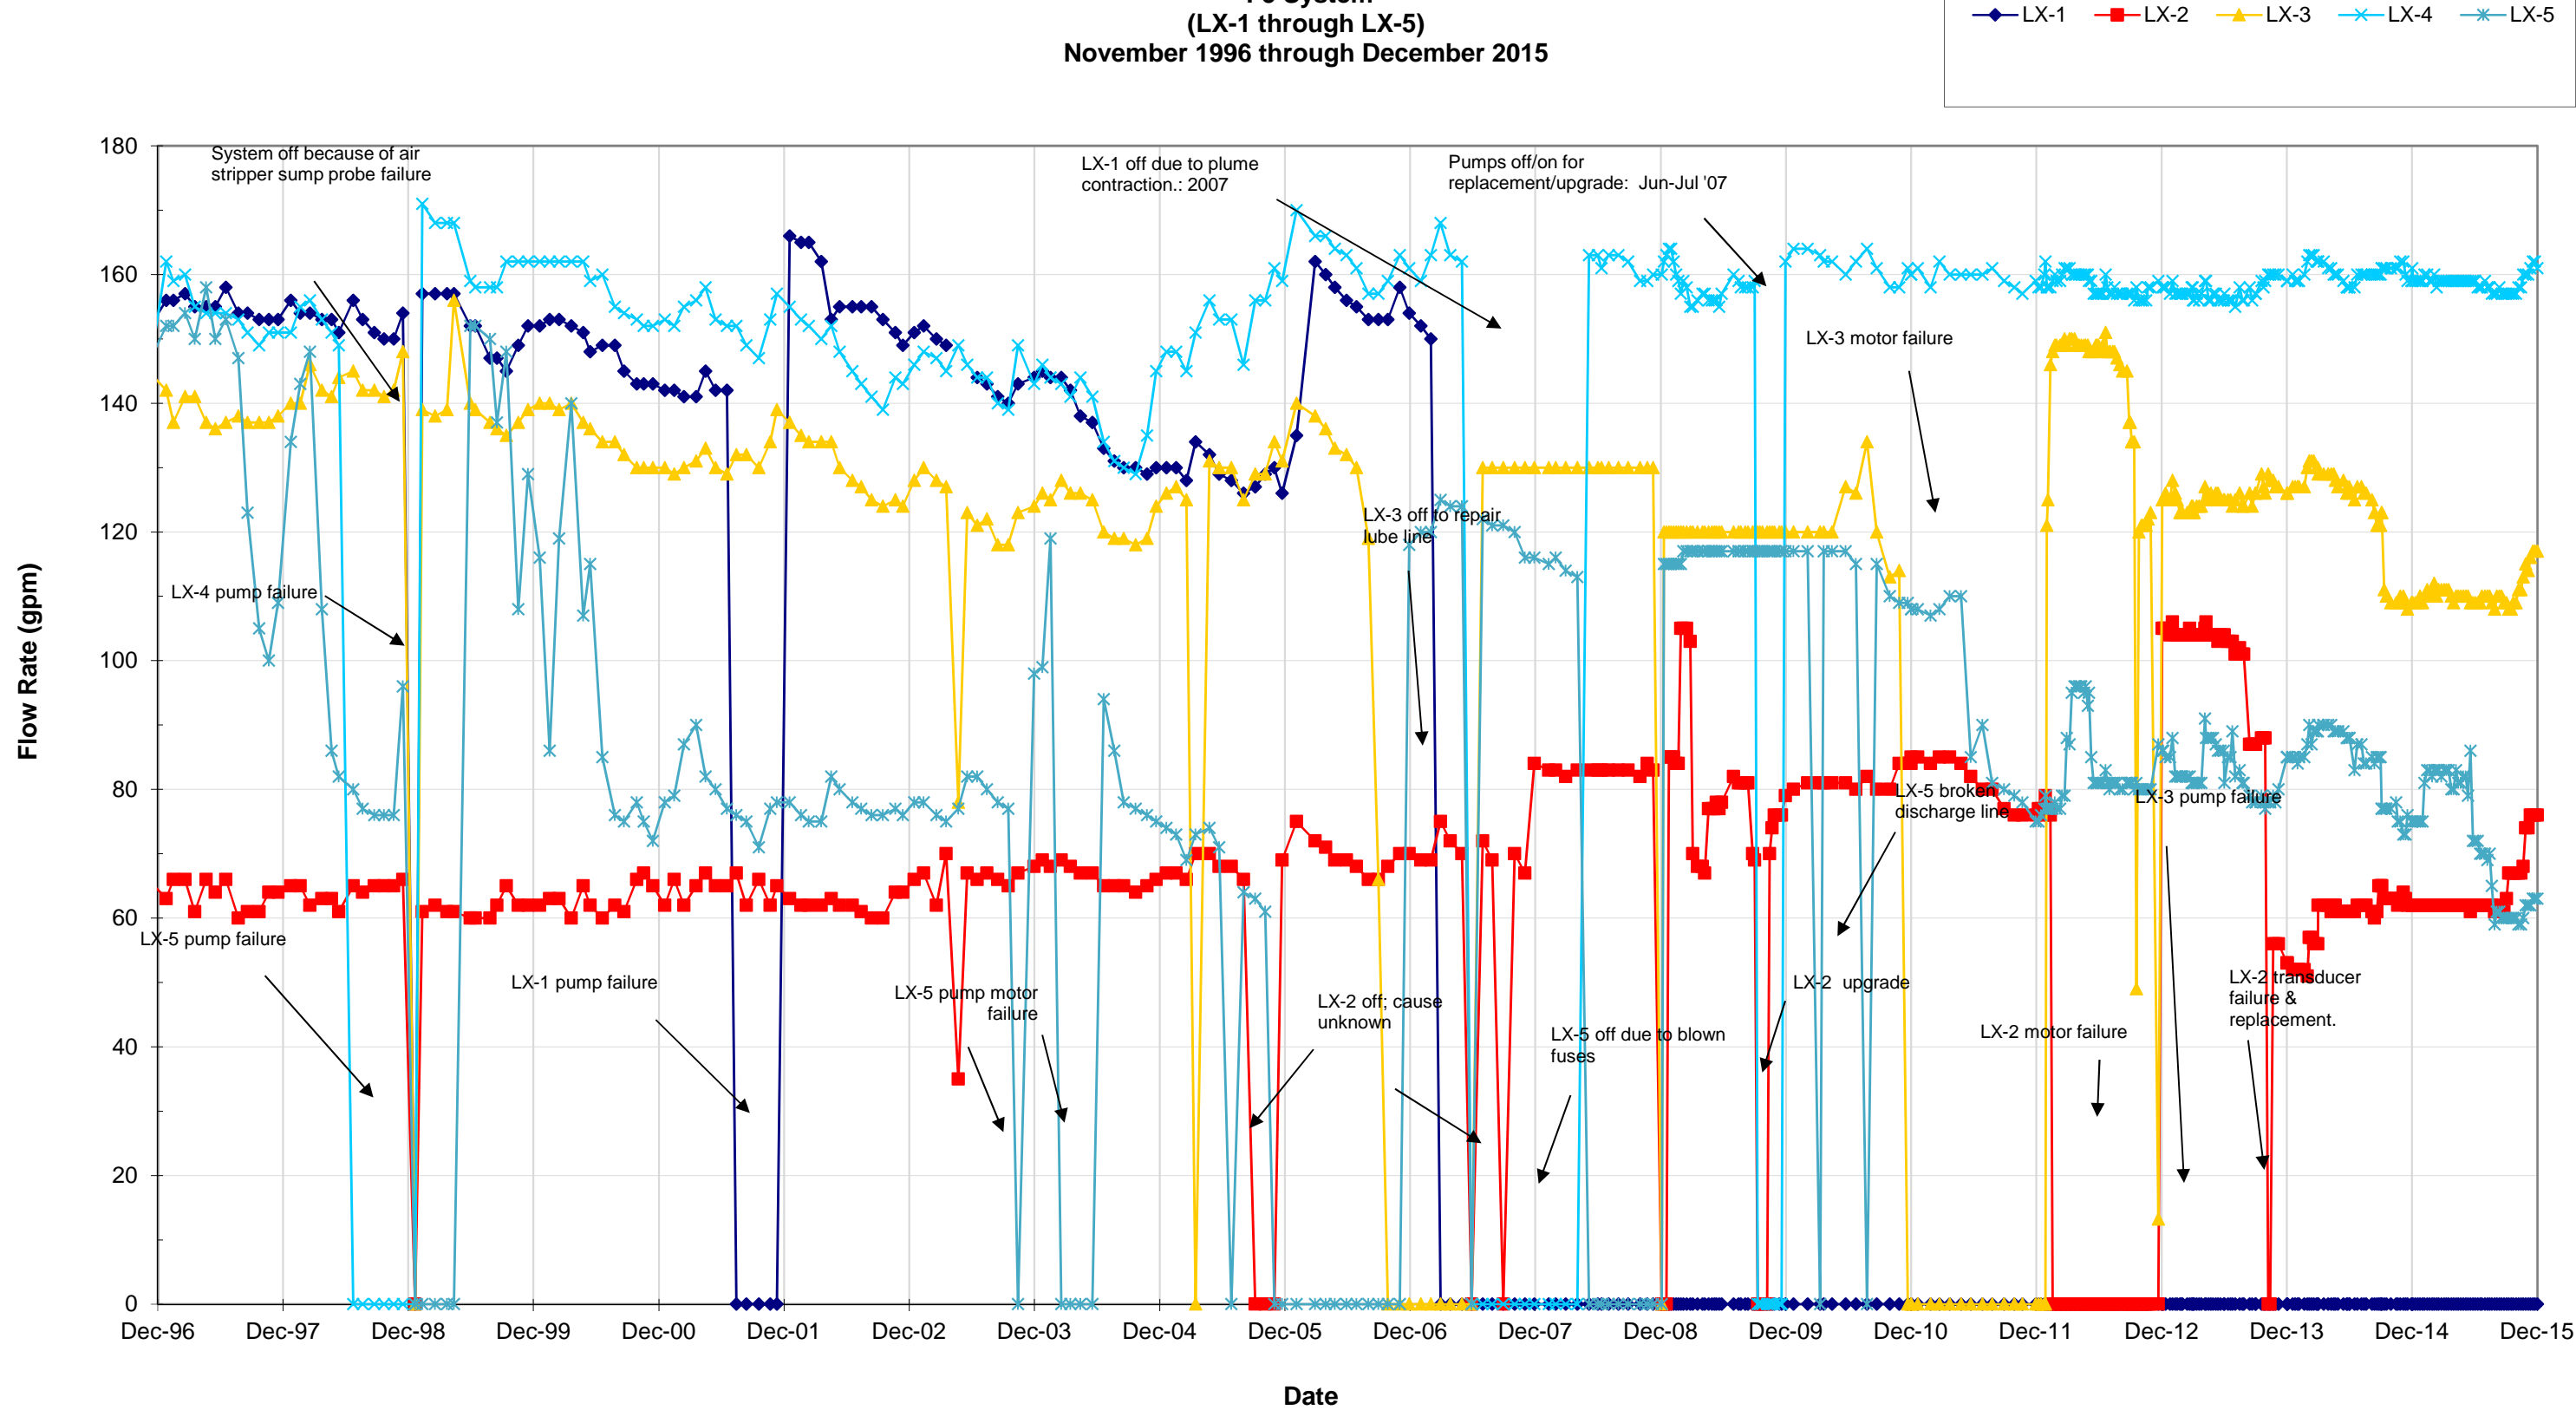
Figure 3-1
Extraction Well Flow Rates Over Time
I-5 System
(LX-1 through LX-5)
November 1996 through December 2015

Note: Pump at LX-1 permanently off: March 5th, 2007. See text for explanation.

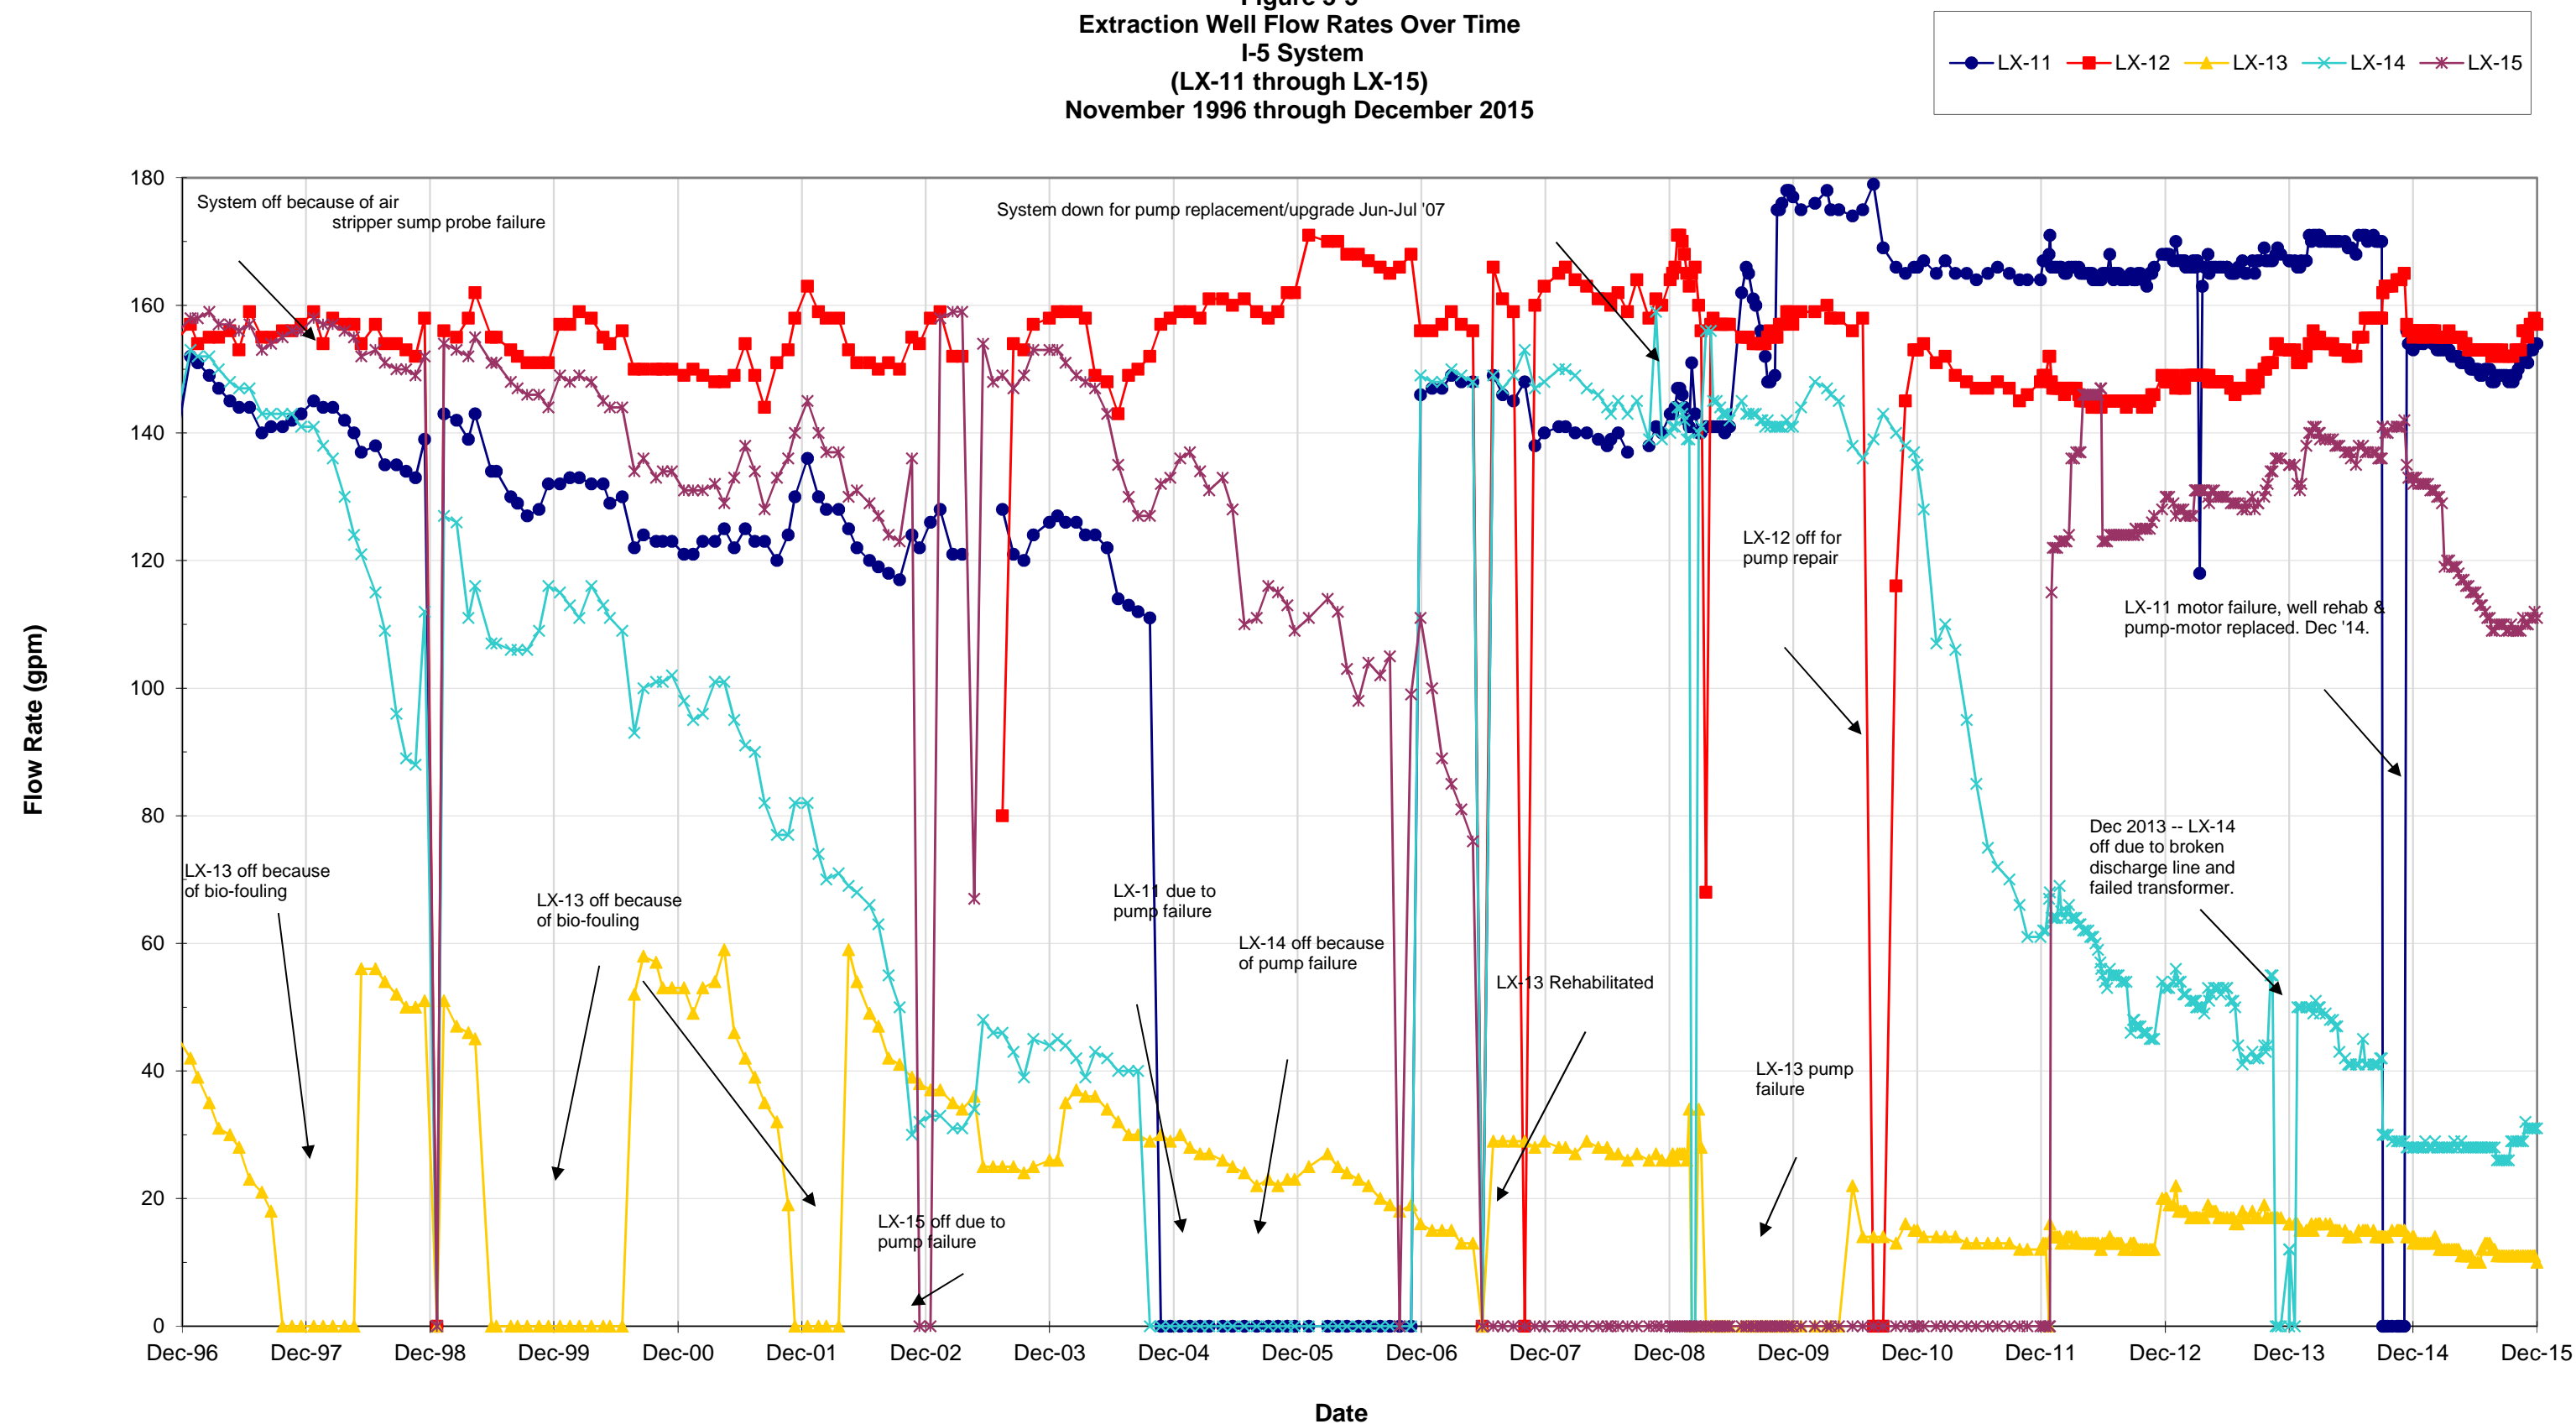
Figure 3-3
Extraction Well Flow Rates Over Time
I-5 System
(LX-11 through LX-15)
November 1996 through December 2015

Note: Pump at LX-15 turned off permanently on June 20th, 2007. See text for explanation.

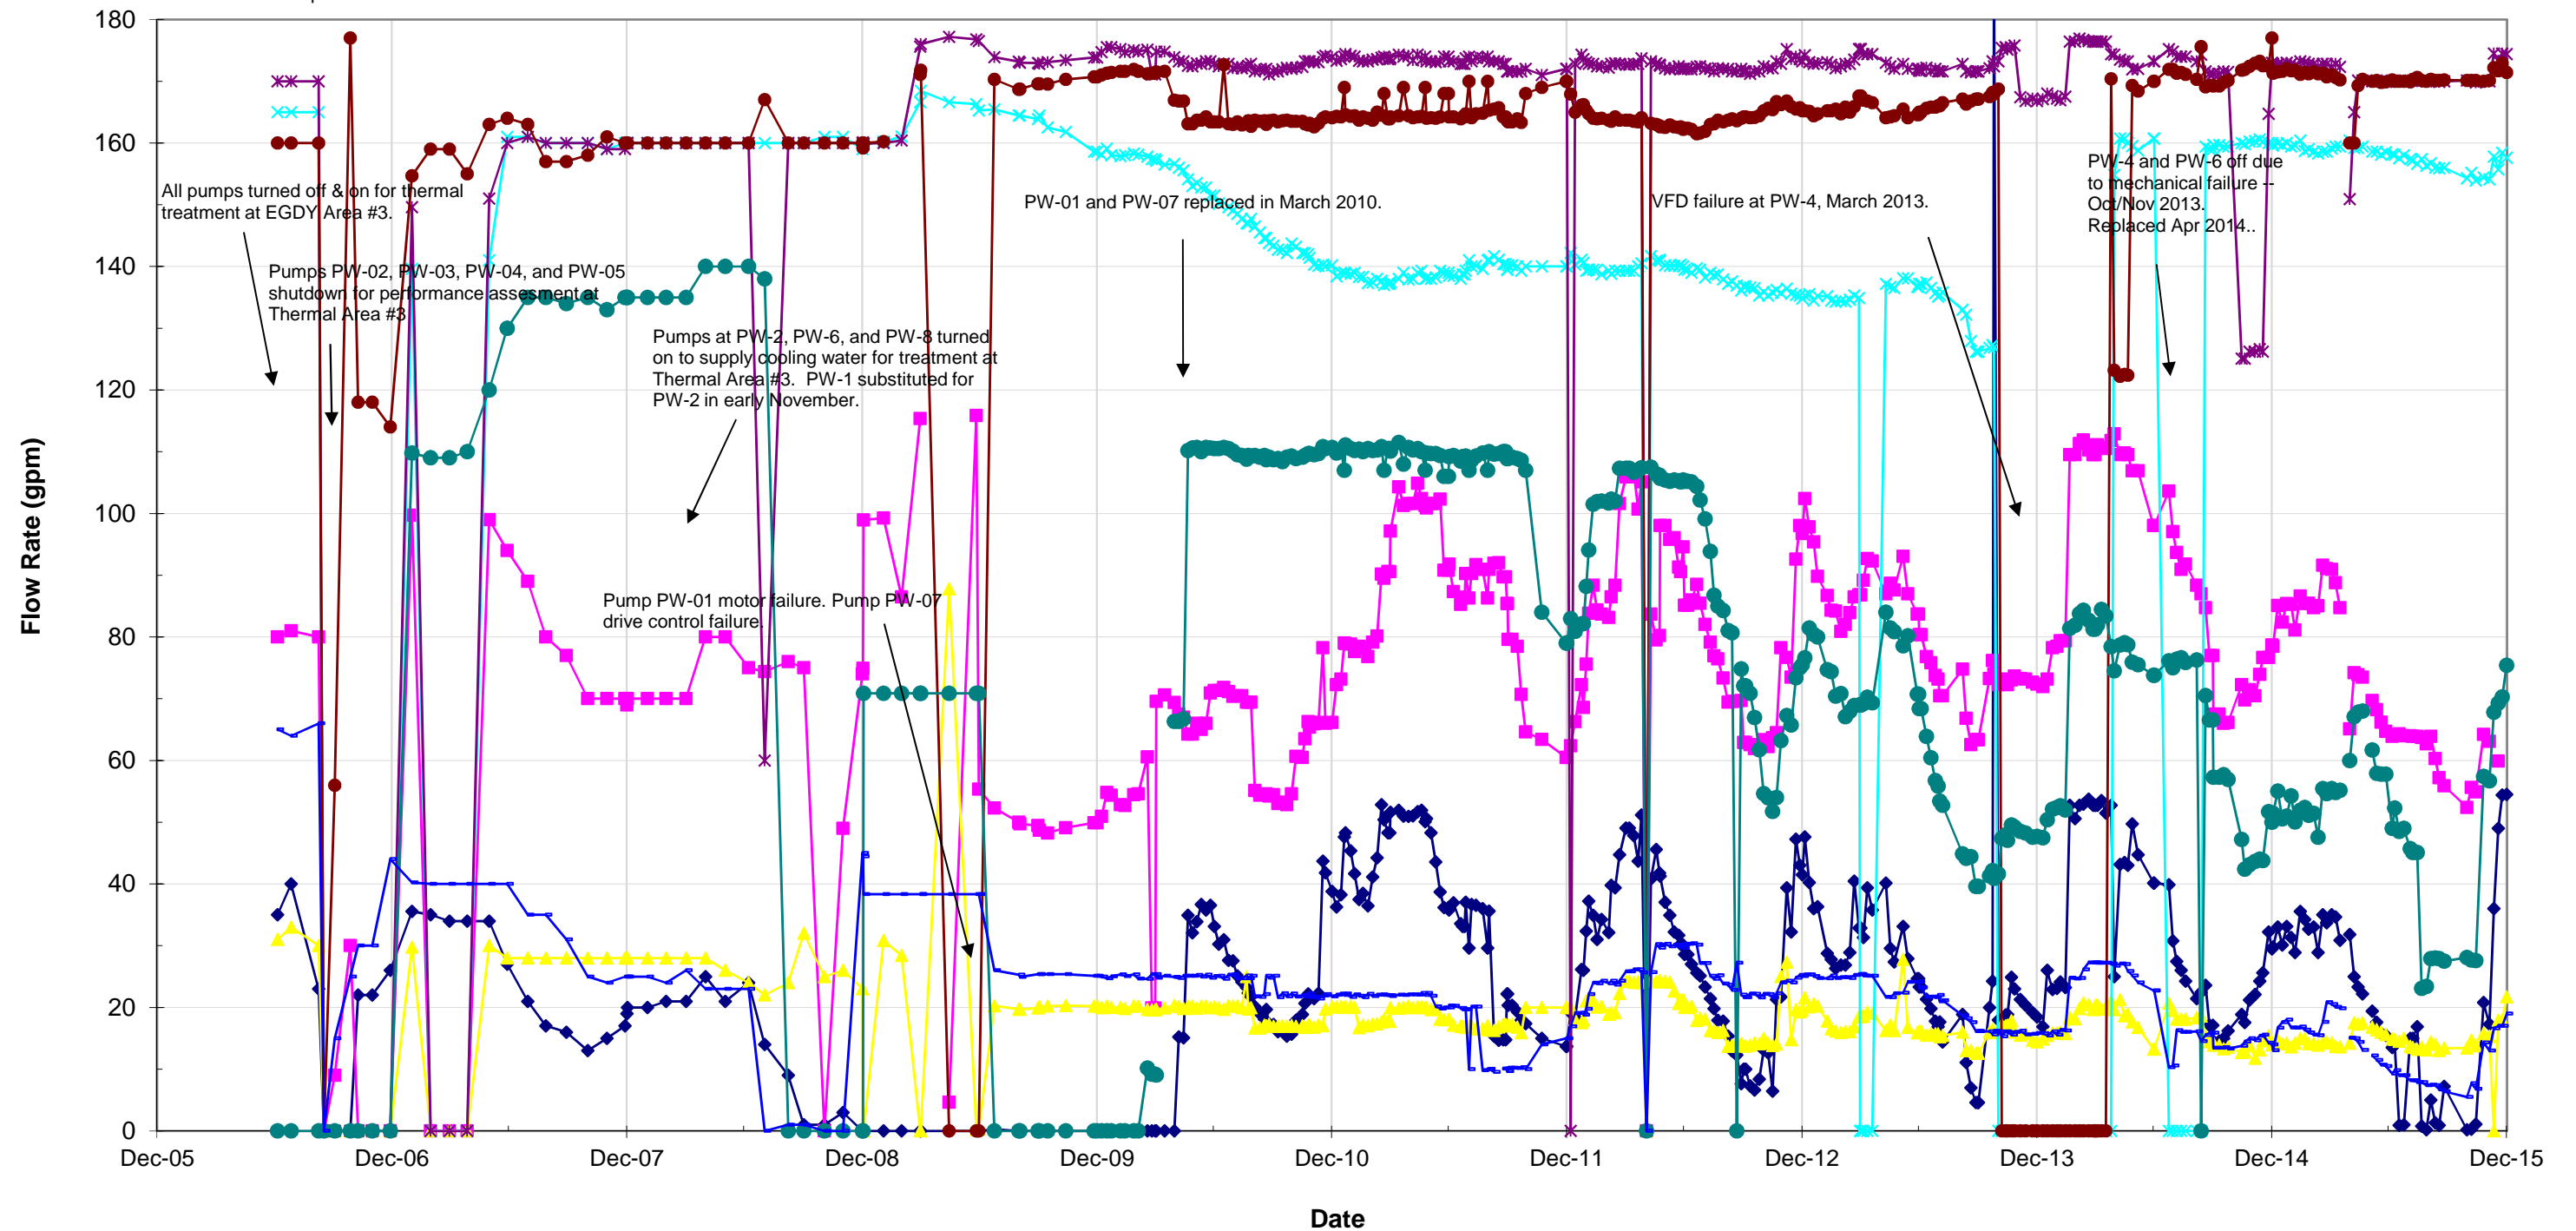
Figure 3-4
Extraction Well Flow Rates Over Time
LF-2 System
(PW-1 through PW-8)
January 2006 through December 2015

Pumps were turned on for continuous operation on 6/29/06. Pumps were run sporadically for pump testing prior to that time, but statistics were not recorded. PW-7 was not turned on due to an inoperable flowmeter.
